Manhole Inspection Summary

Manhole # S31CC_012MH

Inspection ☐ Is Incomplete Rating: **3) Fair**

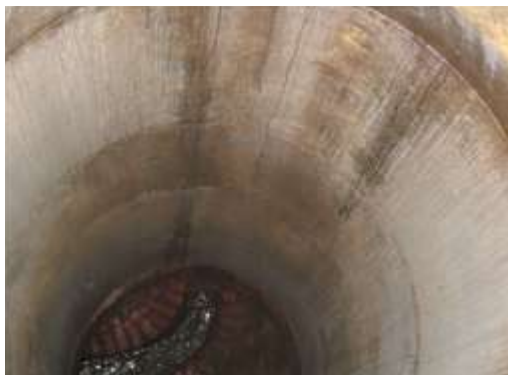
Defect

Evidence of surcharge - Bench debris.

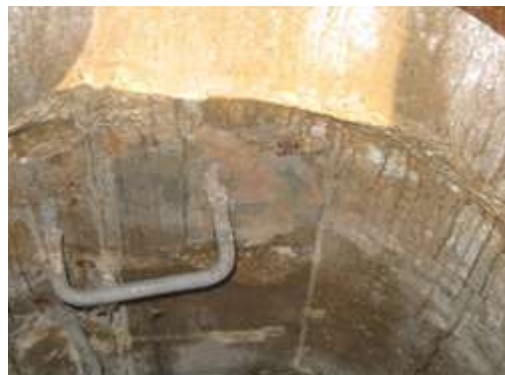
Defect

Corbel and Barrel infiltration.

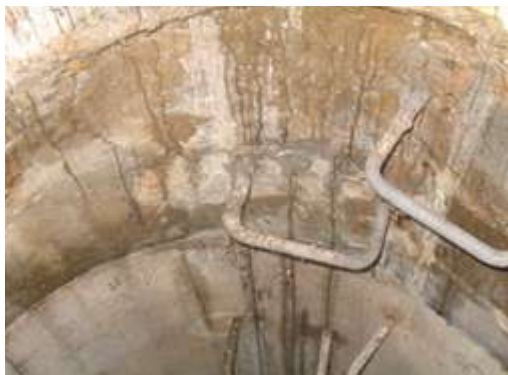
Defect

Adjustment deterioration and infiltration.
Corbel infiltration - other side.

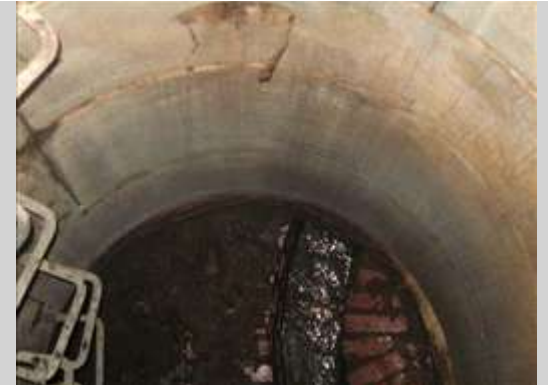
8 in. Circular Gravity Sewer Pipe Out @ 12 O'Clock

Infiltration: **Evidence** Pipe Seal Cond: **Unknown**

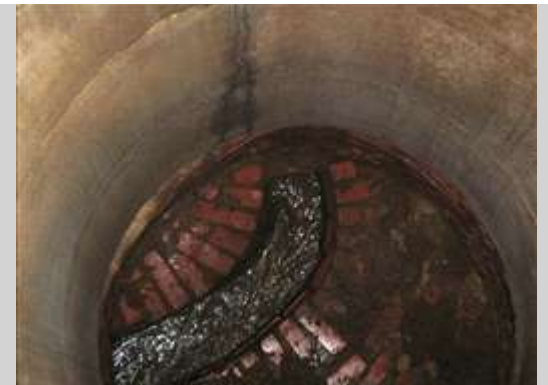
8 in. Circular Gravity Sewer Pipe In @ 3 O'Clock

Infiltration: **Evidence** Pipe Seal Cond: **Unknown**
